# SFA Newsletter

## STRESS CORROSION CRACKING (A MAJOR ISSUE IN ALUMINIUM ALLOYS)

**Lessons from Structural Failures in India****Dr S R Satish Kumar***Department of civil Engineering, IIT Madras, Chennai 600 036*

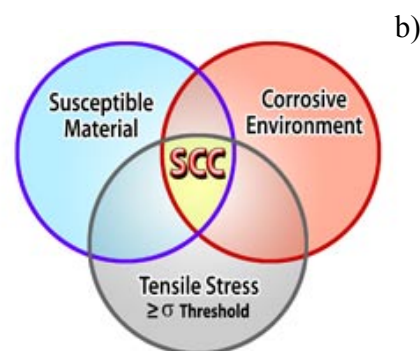
**Figure 1.** Schematic representation of stress corrosion cracking (SCC) phenomenon.

Stress corrosion cracking (SCC) is a cracking phenomenon that occurs in susceptible metals and alloys, and is caused by the conjoint action of tensile stress (stress level must be above some threshold value) and the presence of a specific corrosive environment. The schematic representation of SCC is shown in the figure 1(a,b).
