# SFA Newsletter

## Case study on Metallurgical investigation of Premature Pinion failure in a Helical Gear

### Abstract

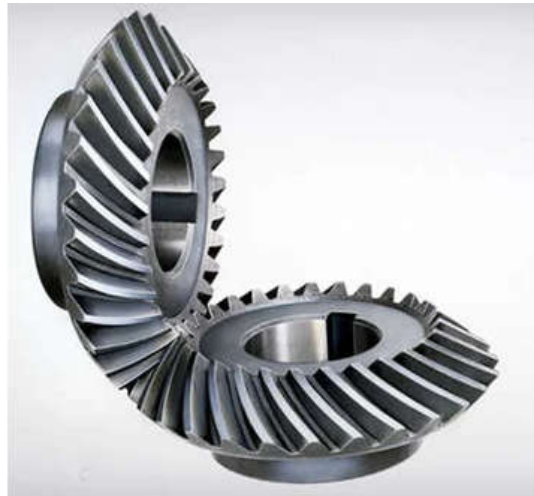
**Fig.1. Appearance of a typical bevel gear**
