# SFA Newsletter

## Engineering Failure Analysis: *Microstructural Evaluation and Interpretation*

### Ignorance leads to ignoring well-known facts

### 3. Reworking Induced Fatigue Fracture of 1<sup>st</sup> Stage Compressor Blades: AL-31FP Aeroengines

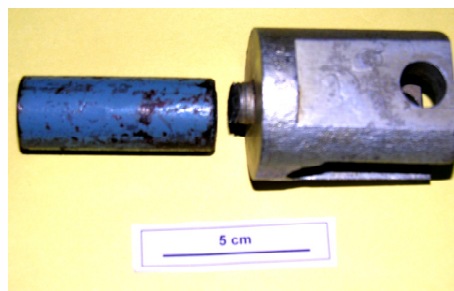
Fork end of a Frame attached with a tie rod has failed suddenly in a brittle manner. The failed fork end and part of the tie rod assembly is shown in Fig. 1a. Fig. 1b shows the failed portion of the tie rod. It is seen from Fig. 1b that failure has occurred inside the tie rod from a thread on the fork end. Fracture surface shows bright features and cracks emanating from the thread groove and also cracks on the surface of the thread as seen in Fig. 1c. The Fork end of the frame and the thread portion were found to have a golden yellow coating.

Fig. 1a Photograph showing as received condition of broken fork end and tie rod of frame.
