# SFA Newsletter

## **An Investigation on the Failure of Inner Cover of a Batch Annealing Furnace**

## TORSIONAL FATIGUE FAILURE OF A TOWER CRANE WIRE ROPE

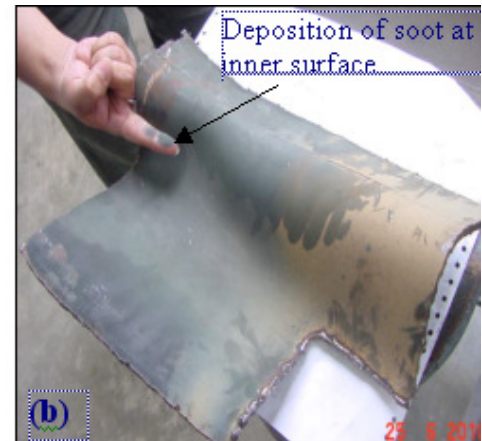
**Fig.2 (a) Sample collected from bulged out part, (b) Deposition of soot at the inner surface**

The inner covers of batch annealing furnaces of a cold rolling mill are bulging out near the burner zone within 2 to 3 years of service. Visual observation of the inner covers reveals deposition of carbon at the inner side as shown in Fig.2 (b). The material of the inner cover is found to be AISI 309S grade of austenitic stainless steel. The detail chemical analysis (Table 1) indicates higher amount of carbon content at the inner surface compared to that of outer surface; carburization occurs at the inner side of the bulged zone of the inner cover near the burners from the deposited carbon on it during annealing of the coils. The primary source of carbon deposited on the inner surface is the oil adherent to

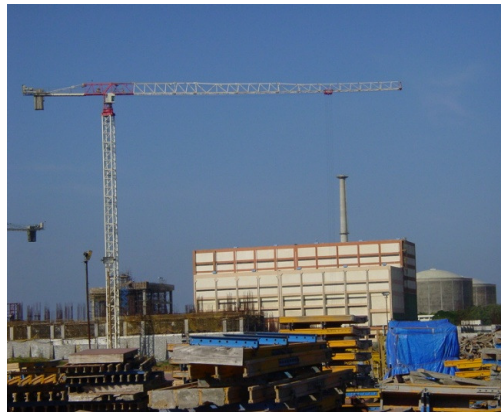
**FIG 1** VIEW OF THE TOWER CRANE

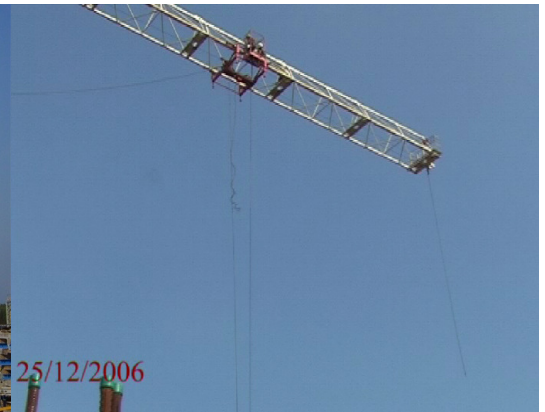
Figures 1 shows the tower crane and figure 2 shows the failure location of the rope along with the crane and close up of view of the failed rope. Fig.3 shows the c/s of actual failed rope and Fig.4 (a) & (b) show the decoloration in the wires. Fig.5 depicts caging of rope.

**FIG 2** FAILURE LOCATION OF ROPE

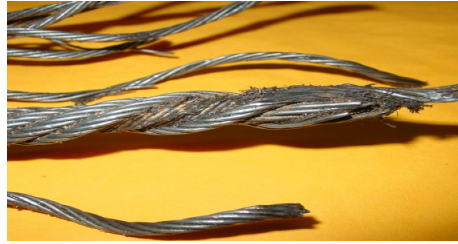
**Fig.4 (b)** ROPE SHOWING DECOLOURISING DUE TO FRICTION HEATING

After the failure of a few strands of the wire in addition to caging of the rope, entanglement of the failed ends on the pulley could have resulted in severe damage to the wires and over heating of the wires due to friction.
